# **FINAL REPORT**

## **LETTS DROP FORGE**

**2714 WEST JEFFERSON AVENUE  
DETROIT, WAYNE COUNTY, MICHIGAN  
48216**

**MARCH 2001**

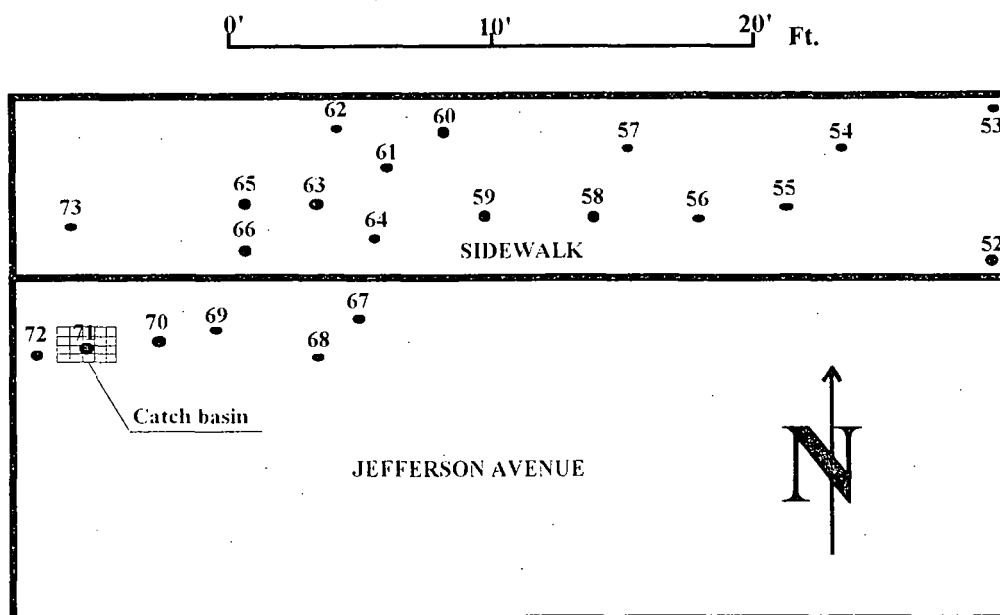
## PCB's WIPE SAMPLE LOCATIONS

Sidewalk wipe samples did exceed 10ug/100cm<sup>2</sup> for four samples. As a result, an approximately 25 to 50 sq ft section of the cement sidewalk was removed and placed into a roll-off box for subsequent disposal at EQ under manifest. The 25ft<sup>2</sup> to 50 ft<sup>2</sup> section of sidewalk concrete was replaced.

In accord with U.S. EPA's request to sample the public sidewalk adjacent and immediately south of the subject property on West Jefferson Avenue, approximately 24 wipe samples were collected along the public sidewalk and street on West Jefferson Avenue. Using 100cm<sup>2</sup> templates, hexane saturated wipe pads were used to wipe the area defined by the template and each sample was placed into a 4-ounce EPA approved pre-cleaned glass container and maintained in a cooler prior to delivery to the laboratory. **FIGURE #5** provides a scaled site drawing of the sidewalk area and identifies sample location.

As a result, an approximately 25 to 50 sq ft section of the cement sidewalk was removed and disposed in a roll-off box and subsequently properly disposed at EQ under manifest. The 25ft to 50 ft section of sidewalk concrete was replaced.

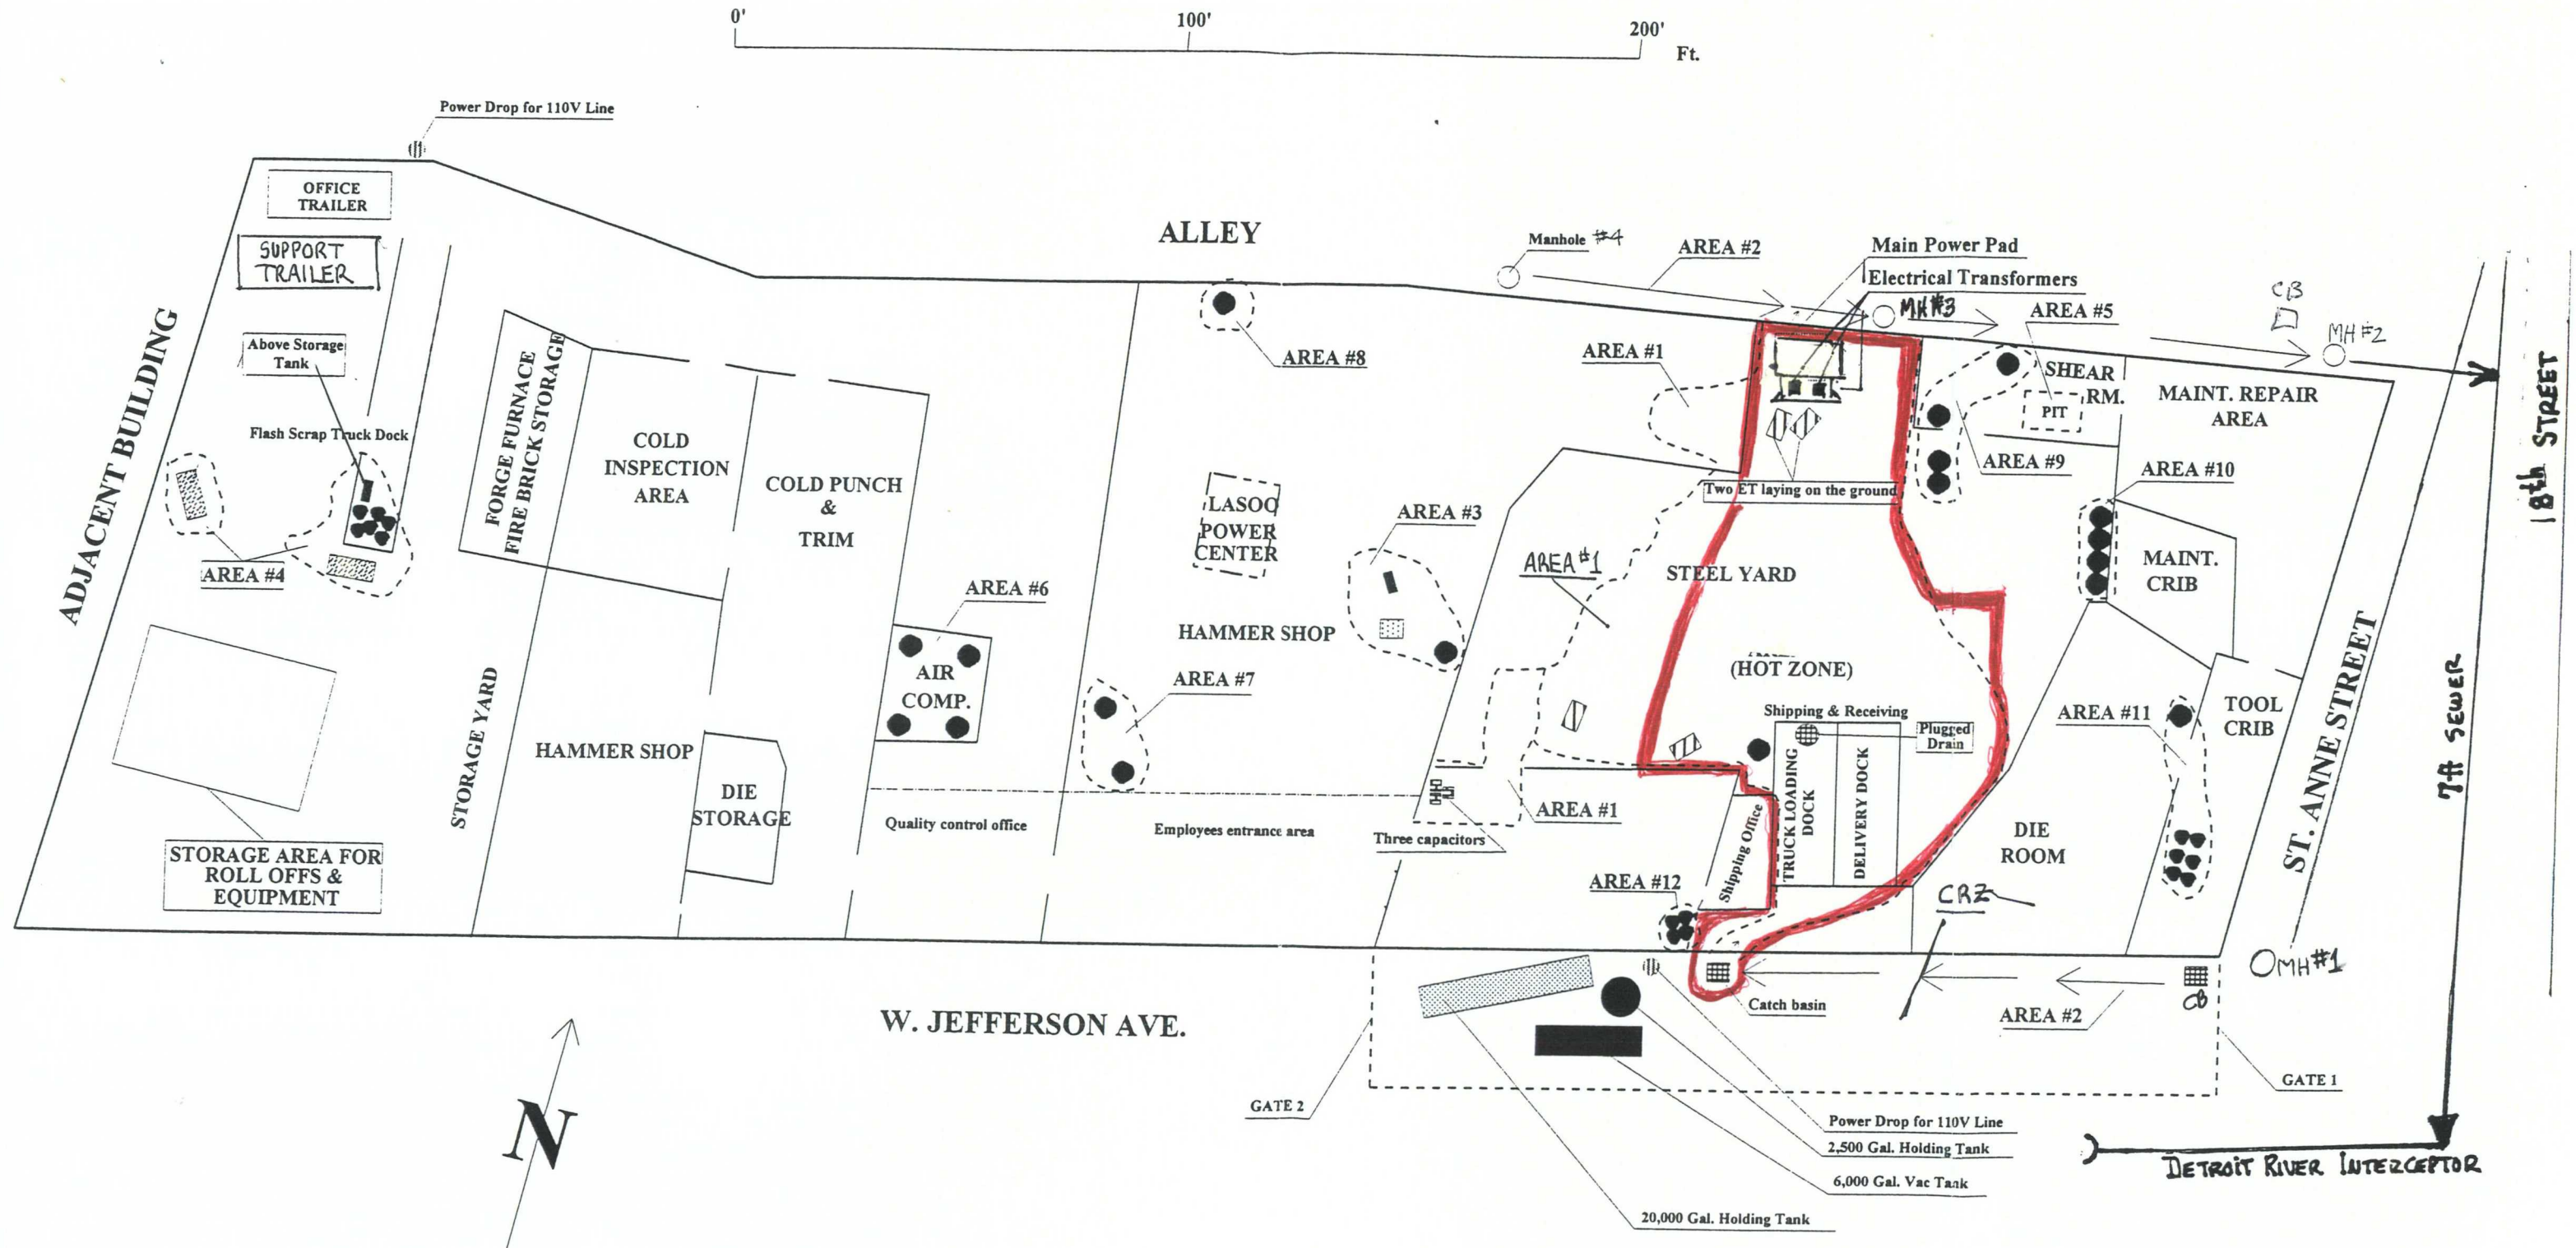
# LETTS DROP FORGE - FACILITY LAYOUT

- Fracture cracks were evident in the concrete of the steel yard and also under the east wing of the hammer shop in Building 2 (Please refer to Figure #2).
- Two ASTs were observed on in the northwest section of the property.

Based on visible observations across the entire site, twelve (12) areas were observed to have visible staining. However, only two areas, namely the steel yard vicinity and the DWSD catch basin #1 (see Table 1, Areas 1 and 2) were determined to be directly impacted by the PCB-containing oil spill from the transformers.

For purposes of identification, ENMANCO numerically designated areas of the spill, as well as the areas where staining and various containers were sited, on an attached site diagram (**Figure #2**). The general description of these areas is as follows:

Reference is made to Figures #2 and #3, which depict the specific locations of the above analyzed catch basins and sumps. As may be seen above, only catch basin #1 (CB1), which was located on West Jefferson in front of the steel yard gate and initially observed to be impacted with oil, was identified as containing arochlor 1260 at a concentration of 1000 ppb (parts per billion).
